PORTSMOUTH CATHEDRAL

by Simon L Ablett, Cathedral Architect

Seeing the cathedral from a different viewpoint

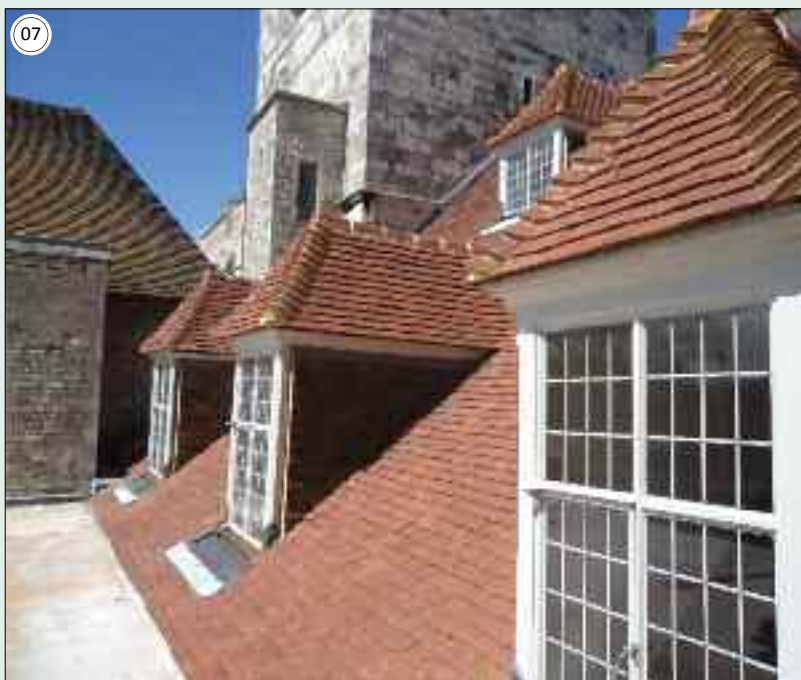
07 The south roof looking west after work
