PORTSMOUTH CATHEDRAL

by Simon L Ablett, Cathedral Architect

Seeing the cathedral from a different viewpoint

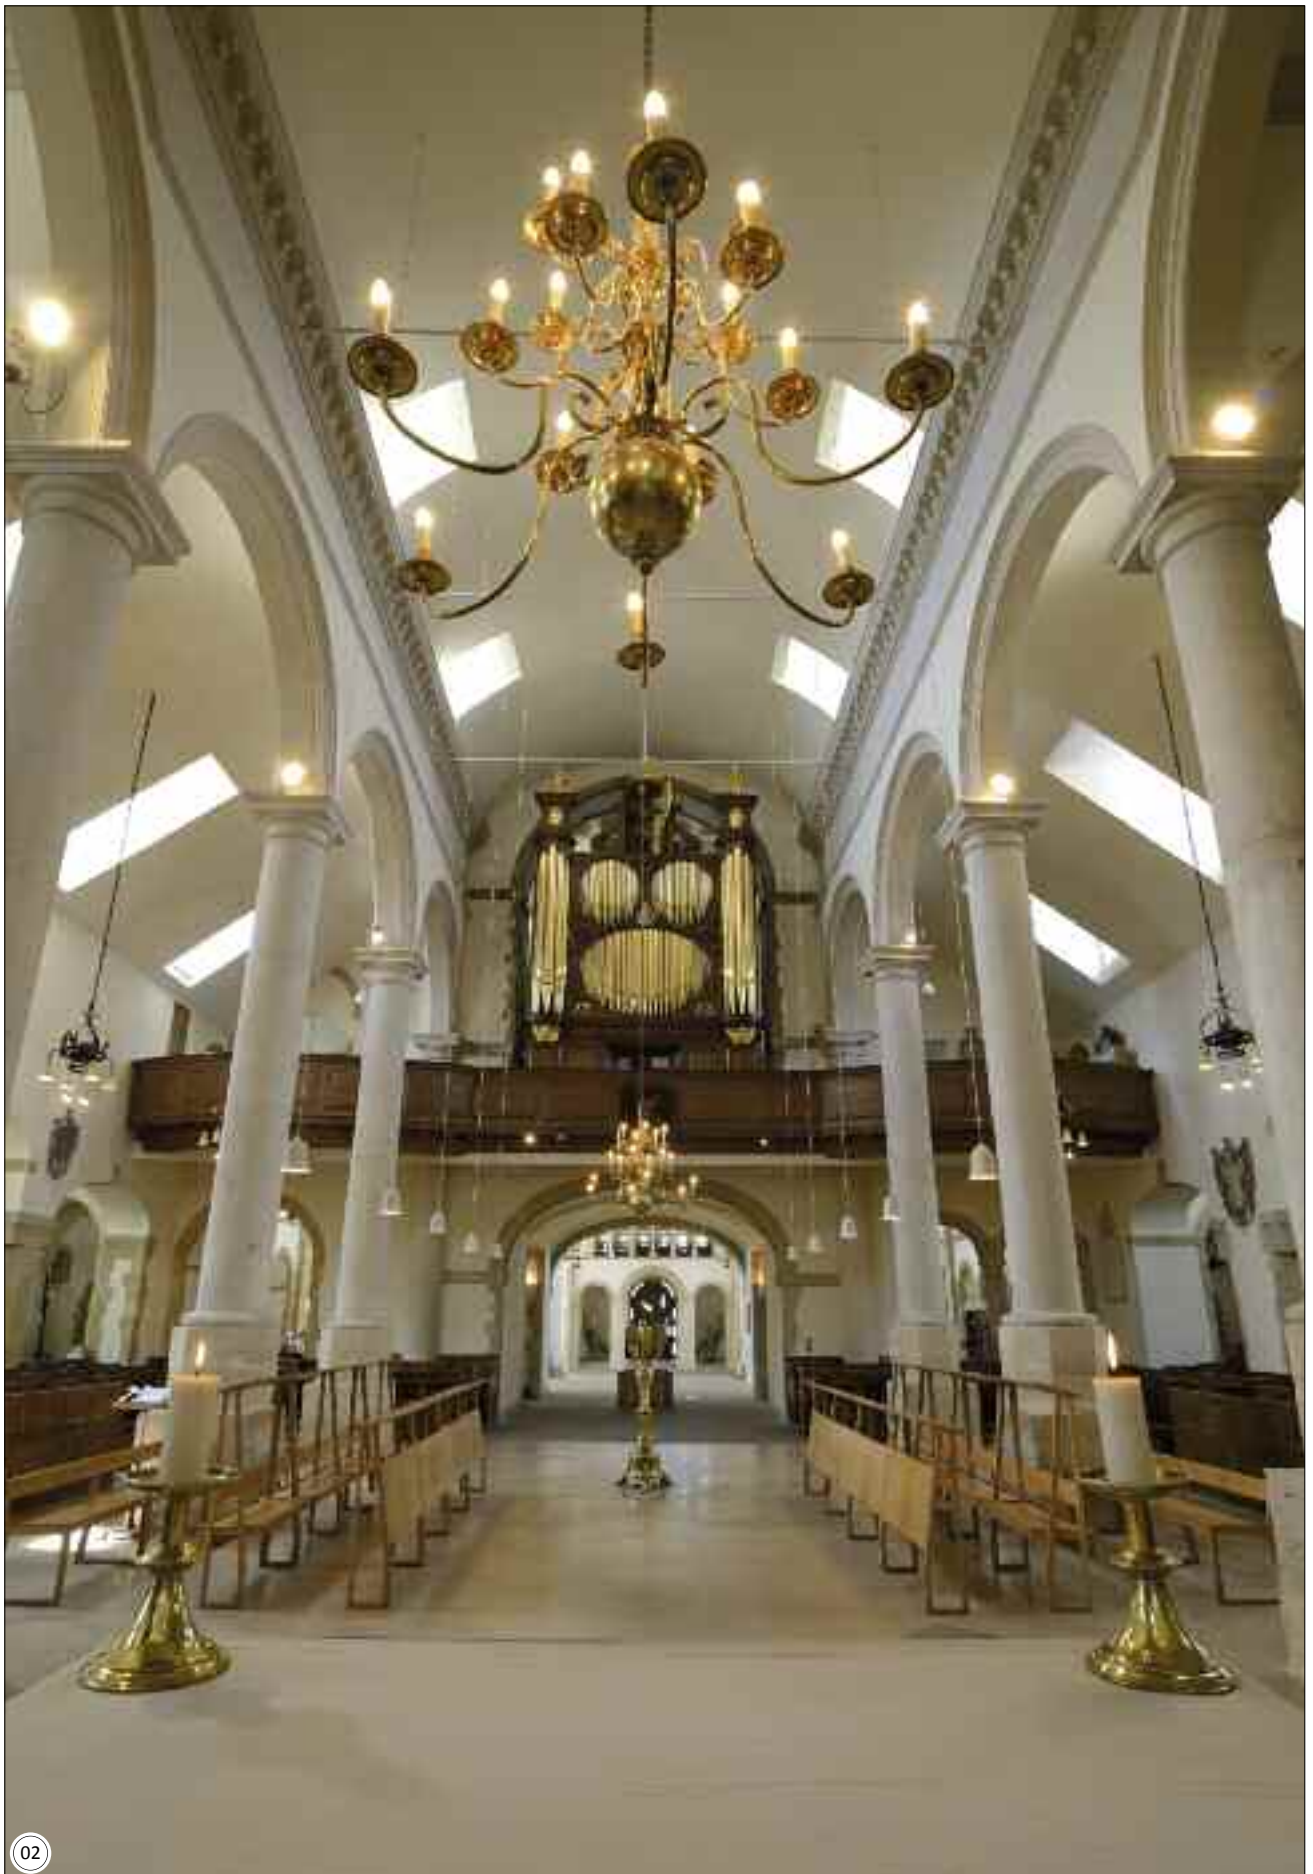
- 01 South Tower view
- 02 Quire towards organ
© Jonty M Sexton
- 03 Chapel of St Thomas
vault looking east
- 04 Quire ceiling during
the works
- 05 The north roof in
progress
- 06 The north roof in
progress
